January 5, 2010

Re: Malakoff Elementary School
1940 School Building
Malakoff, Texas

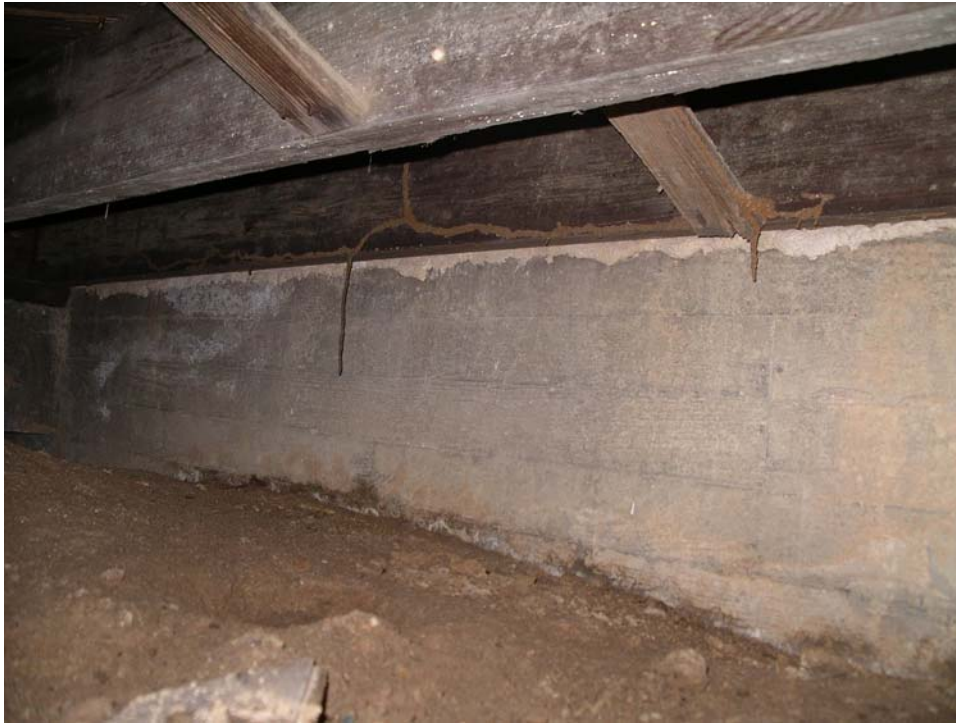
Of the 24 access holes, photographs in 4 of them indicated signs of past termite presence in the form of dirt tunnels. Note that this does not necessarily indicate current termite activity, and it also does not necessarily indicate significant damage. With the amount of moisture present in the underfloor subgrade this level of past termite activity is not surprising. This percentage of termite involvement is high enough to indicate there is probable damage to some of the wood members, but probably low enough to indicate that this damage is probably not especially widespread. The evidence of past termites presence seemed more prevalent in the eastern half of the building than in the western half.

#5743 – Evidence of past termite presence may indicate damage.

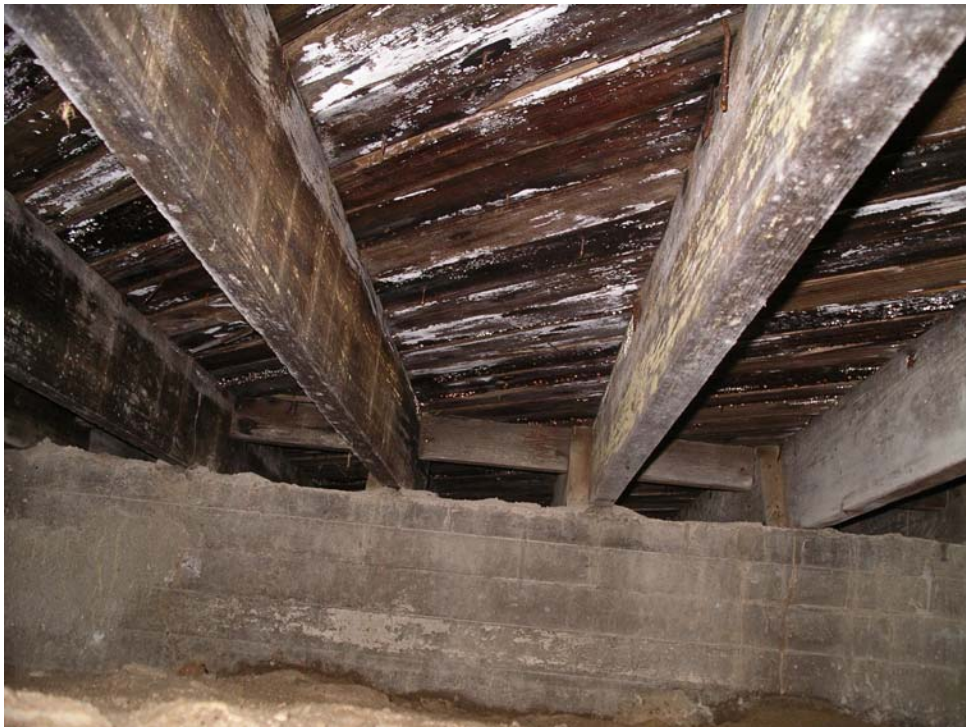
The wood floor structure definitely shows evidence of moisture-induced damage, but it appears to be somewhat isolated and minor.

#5751 – Extreme humidity has caused moderate damage to the floor structure.

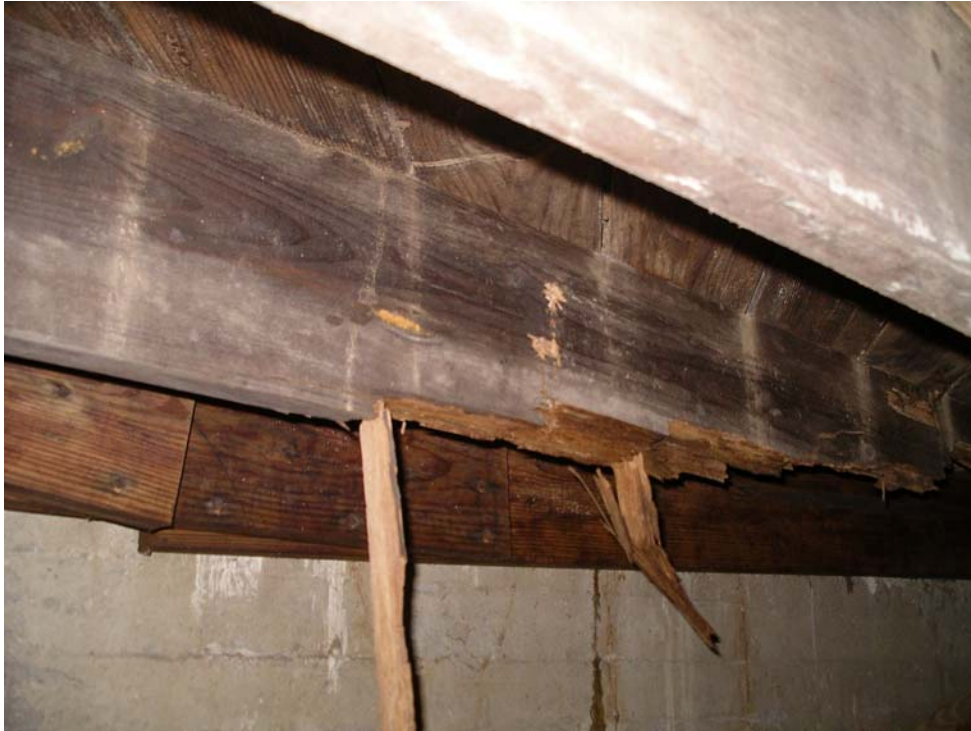
Other forms of potential damage, including a white substance with the appearance of mold, and some actual wood decay, were observed on a very occasional basis throughout the building. These abnormalities were so isolated that they do not imply a regular pattern of distress.

#5636 – There is isolated damage to floor members.

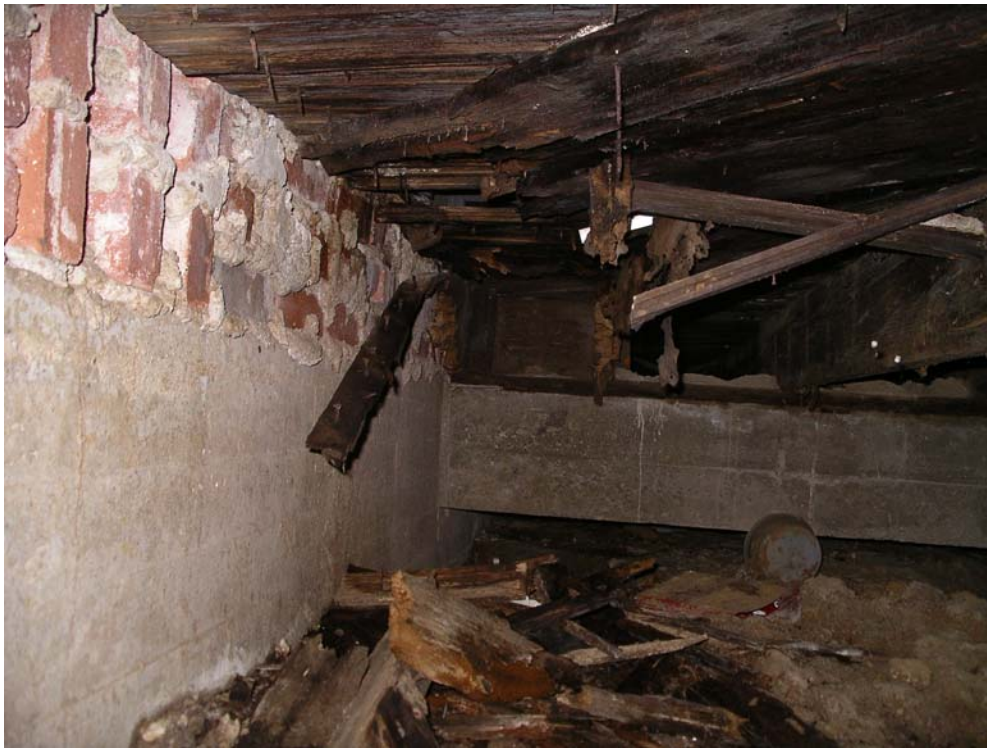
#5760 – Fire damage is quite localized.
